EXHIBIT “C-2”

G. ANALYSIS:

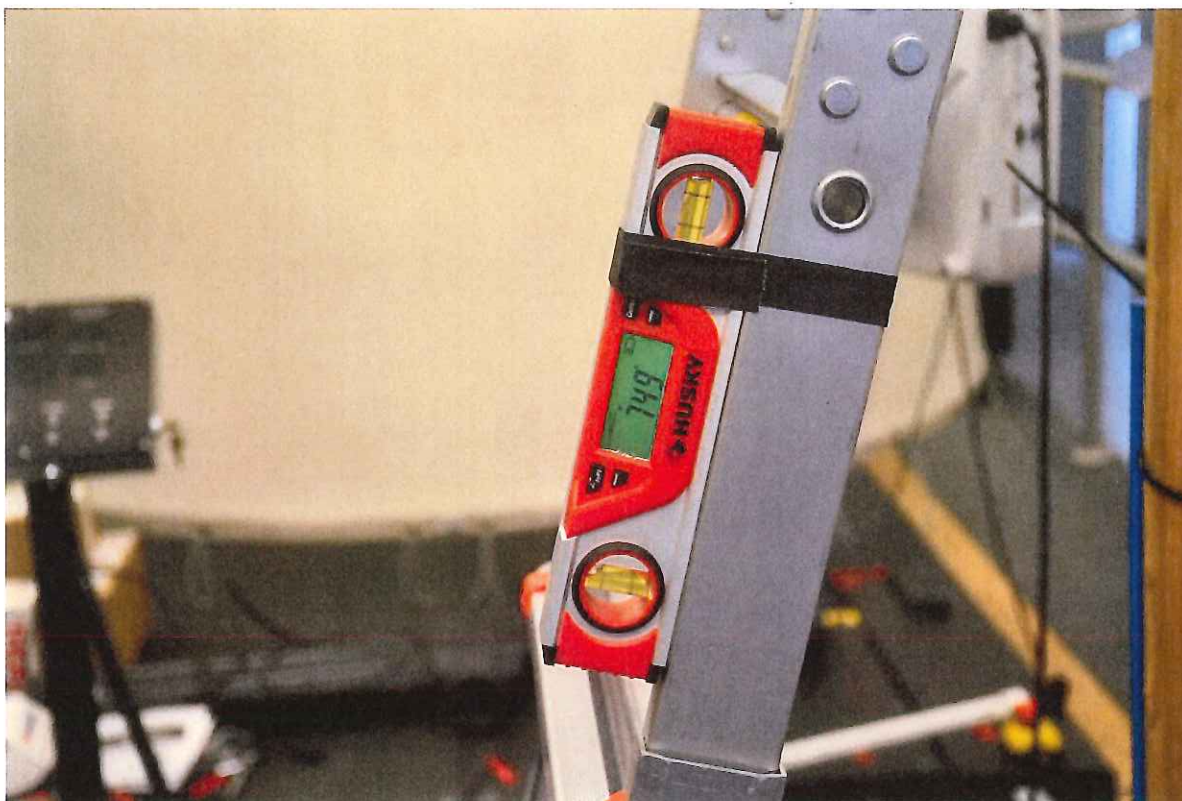
In order for the ladder to be set up at the proper angle against a rigid structure, a wooden scaffold was constructed on site. It was located in the laboratory such that when the exemplar ladder was placed against it at an angle of 75 degrees, each foot of the ladder would be located on a force plate. The plates were located sufficiently close to one another that this was possible.

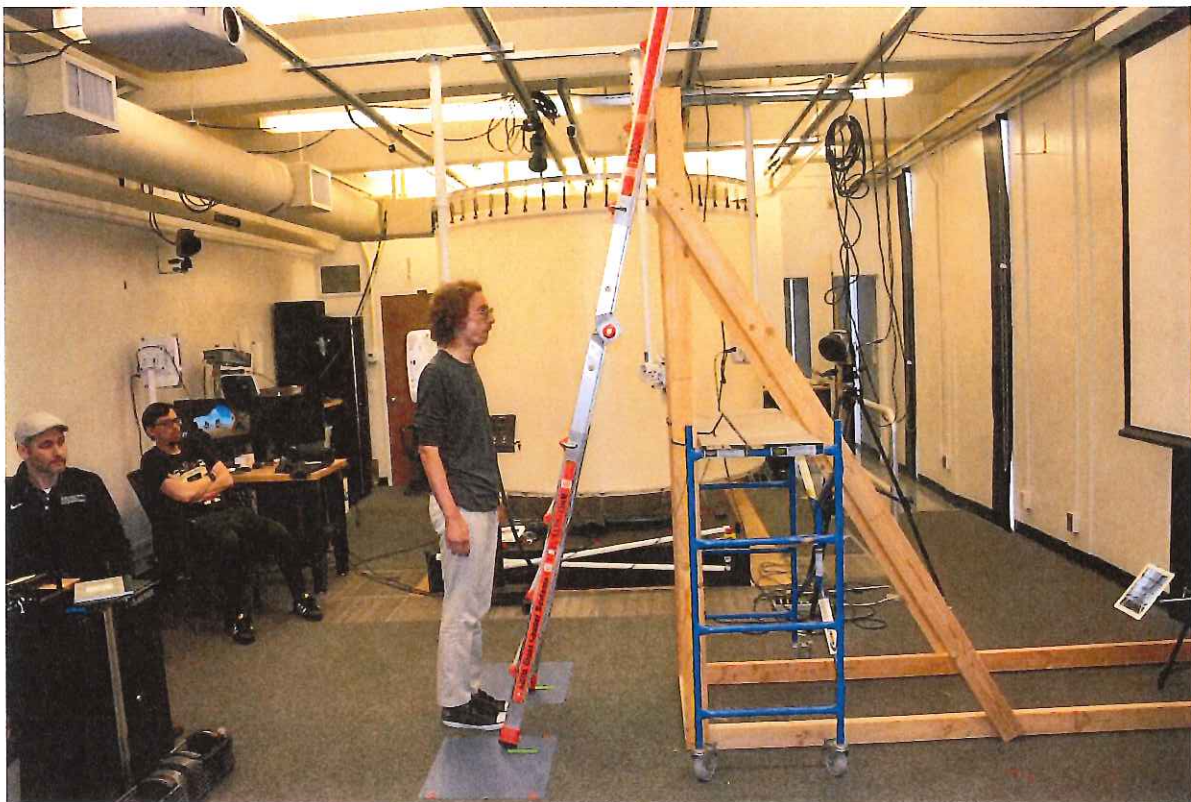
Two students were recruited to ascend and descend the ladder. Both were male, and both expressed having had some experience climbing ladders. They were instructed to climb the ladder using three point of contact technique, up to the lowest rung of the upper extension. They were then to pause on that rung for approximately five seconds, and then descend. Data was recorded from the force plates during the entirety of each excursion.

The data gathered during this testing, as well as a detailed accounting of the testing procedures, description of the testing equipment and analysis of the data is contained in the expert report of Dr. Peter Francis.

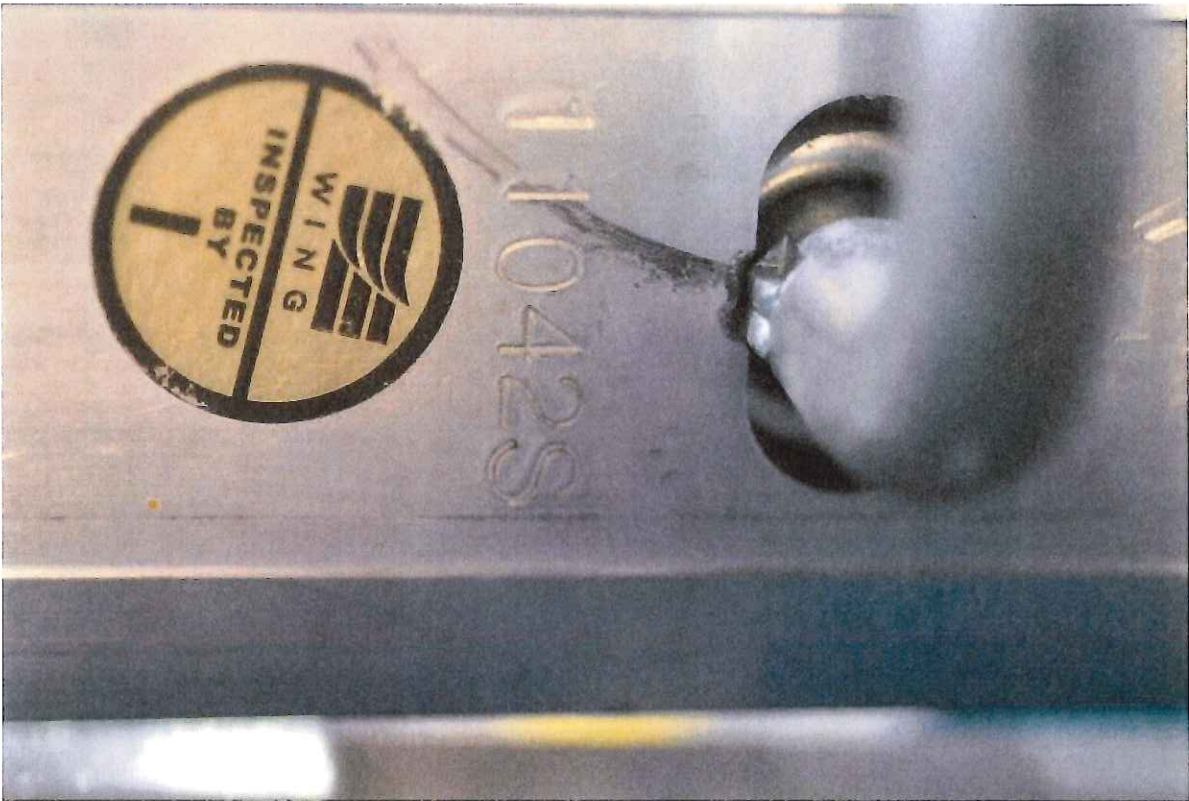
When the Little Giant Alta-One ladders being tested false locked, the tip of the J-lock rested on the inner lip of the swage ring present around the base rail hole. It was held in place by the J-lock spring, which applied a force pushing the tip into the ring, as well as by the weight of the extension being applied to the top of the J-bar through contact of the inside of the extension hole with the top of the J-bar. This defective condition can be ameliorated by eliminating the swage ring. Alternative methods of attachment such as welding could have and should have been utilized, followed by a grinding operation to smooth the surface and bevel the edge, facilitating J-lock insertion and eliminating the very location and geometry where the false lock occurs.
